NAVY EXPERIMENTAL DIVING UNIT

EVALUATION REPORT 6-56

FLATUS II ŞEMI-ÇLOSED CIRCUIT MIXED GAS SCUBA

PROJECT NS186-202 SUBTASK 2 TEST 8

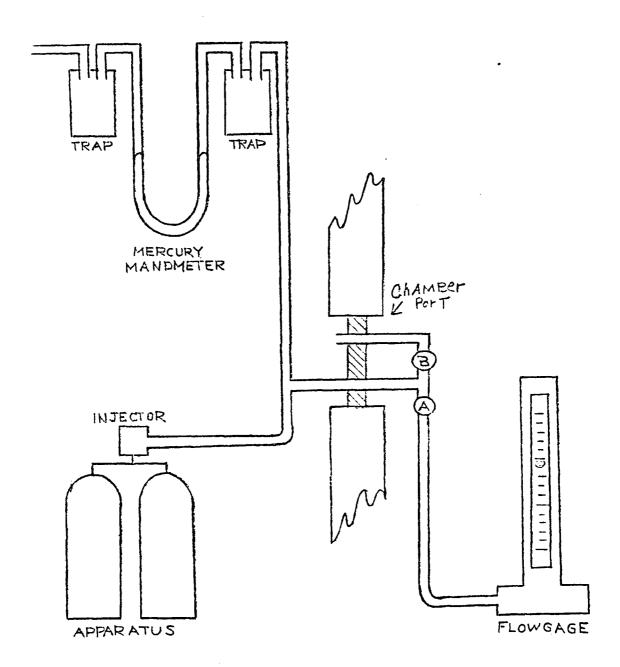
FIGURE 51

- 7.3.1 Figure S-1 shows method of rigging chamber for depth flow stability test.
- 7.3.2 Figure S-2 show schematic diagram of Flatus II.

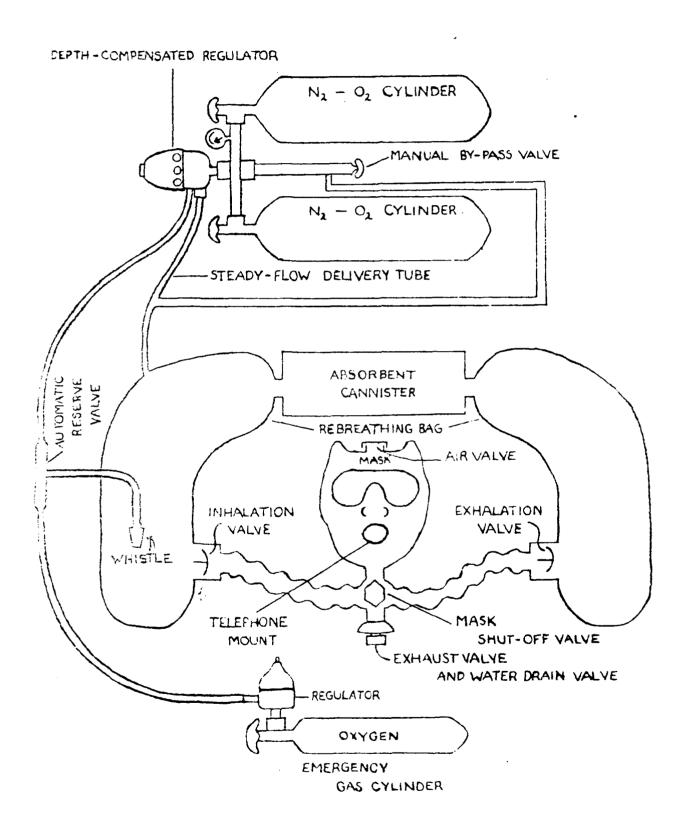
FIGURE S2

SCHEMATIC DIAGRAM OF FLATUS II
